Executive Summary

The Equal Opportunities Commission in collaboration with the Uganda National Action for Persons with Disabilities undertook an audit exercise to establish the level of accessibility to public buildings by Persons with Disabilities in Uganda. The exercise was conducted among selected public facilities in Kampala i.e. Kampala Capital City Authority, Centenary Rural development Bank-Mapeera House, The High Court in Kampala, Kiruddu Health Centre IV Makindye and the Parliamentary building of the Republic of Uganda.

3.1.2 Audit findings for KCCA City Hall building

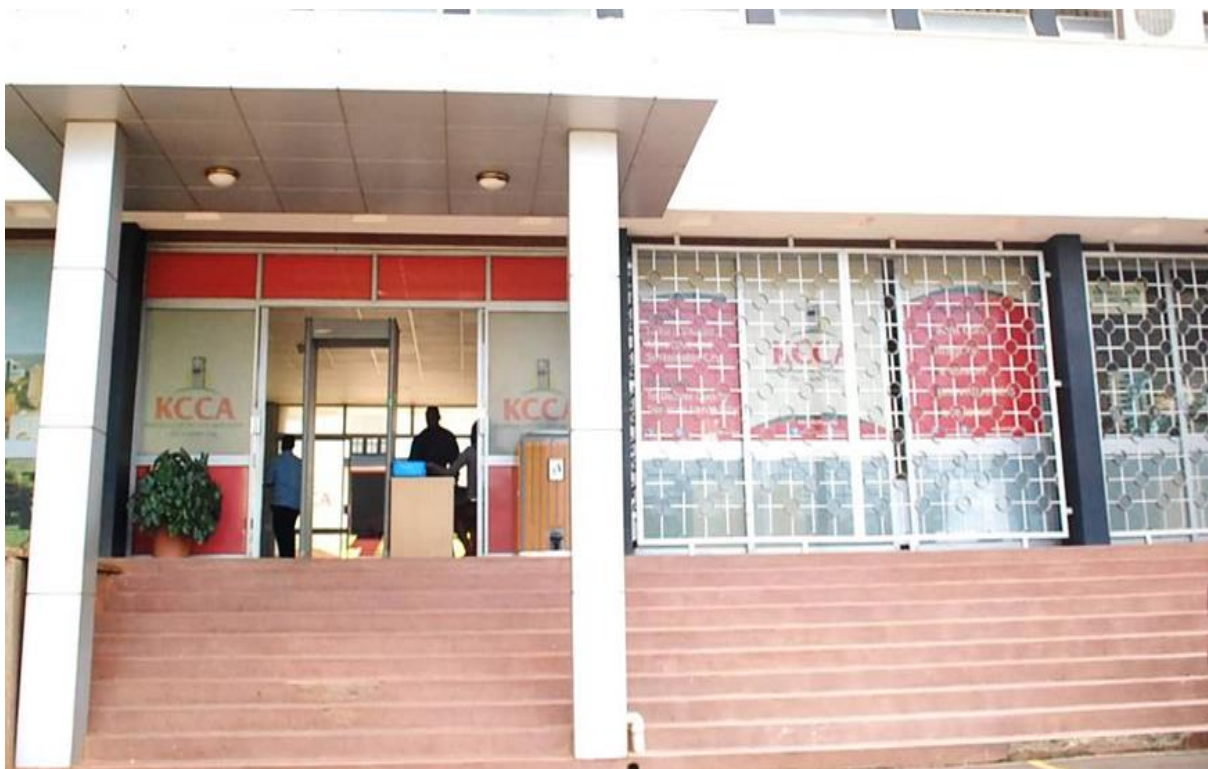
- i. The main entrance to KCCA office premises is not accessible for PWDs as it does not provide for a ramp and the stairs in place do not have tactile marking for identification by the visually impaired. In addition, the alternative entrance has a ramp, albeit without handrails and landing area.

Main Entrance to KCCA office building which is inaccessible for PWDs

- i. KCCA should construct an accessible ramp at the main entrance to City Hall building to ease access for all especially Persons with Disabilities.
- ii. It is recommended that handrails be set up at the outdoor steps/stairs at the main entrance.
- iii. Appropriate parking space should be designated and marked off for persons with disabilities.
- iv. Modifications should be made on the ramp at the alternative entrance to add standard features such as; handrails and a landing area to ease access for PWDs.
- v. Appropriate measures should be taken to ensure easy access for PWDs to the chamber hall. The steps at the door entrance to the chamber hall limit accessibility for Persons with Disabilities especially wheel chair users.
- vi. Information display at the Public Notice Board should be placed in large print to ease access by the visually impaired.

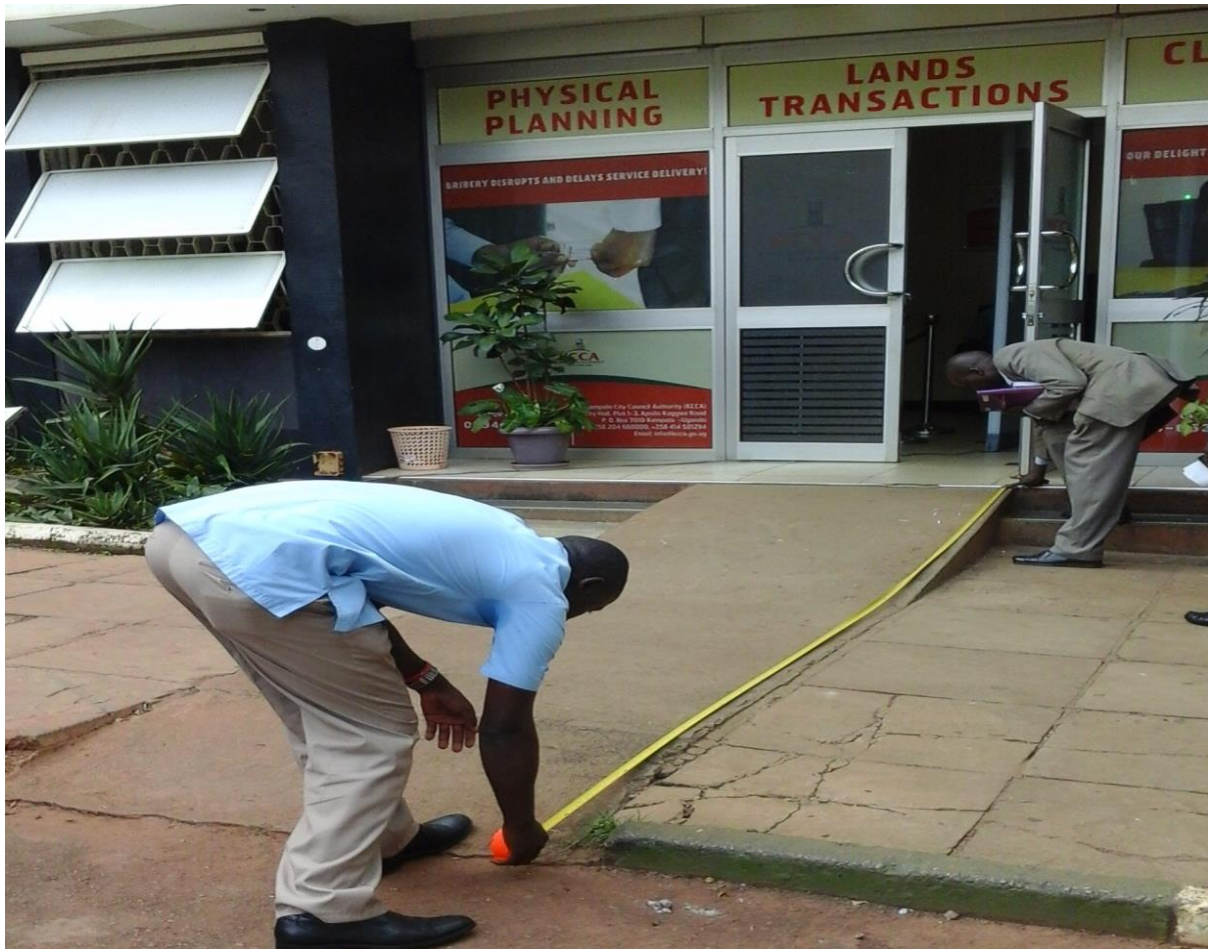
Existing ramp at the alternative entrance to KCCA premises without handrails and landing area

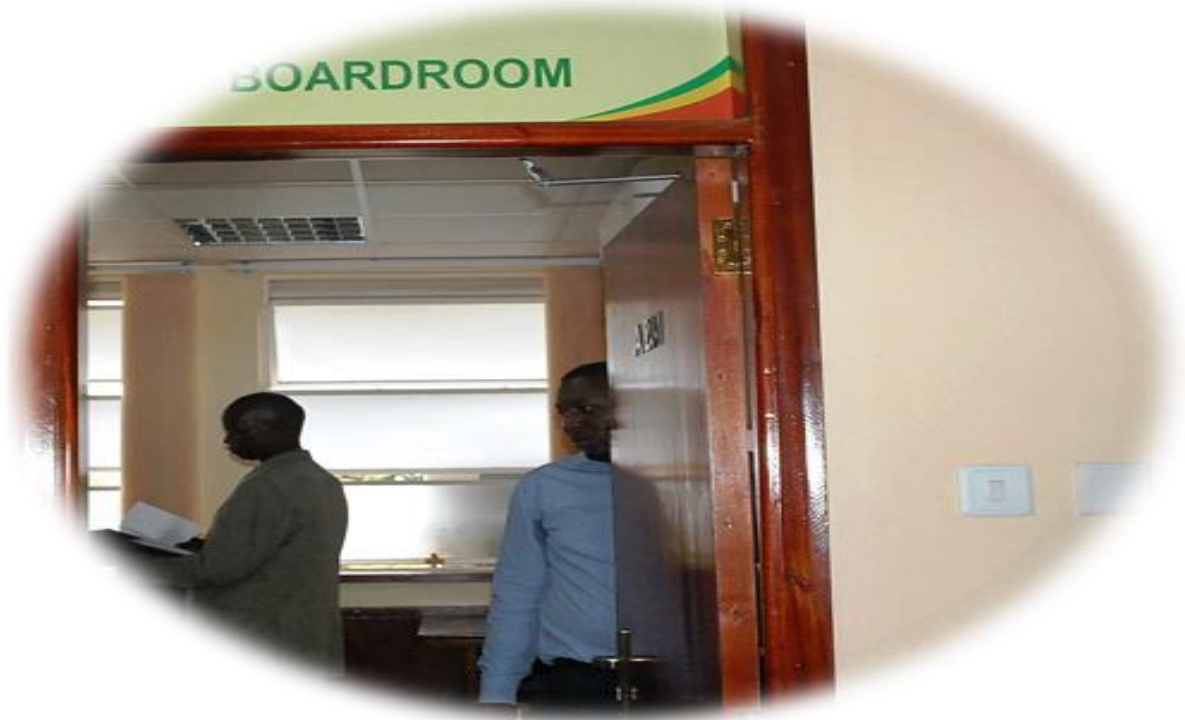
- ii. The interior stair cases were wide enough with handrails and had a wide landing area. However, the tactile markings are getting worn out and the rails on interior stairs are very smooth to be gripped in case of extra support.
- iii. The interior single leaf doors don't rest flat against the wall which reduces the opening space for wheelchair users and the door handles are placed very high for wheel chair users and little persons. The glass doors observed in the building are not marked for easy identification by the visually impaired.

Interior single leaf door in KCCA boardroom

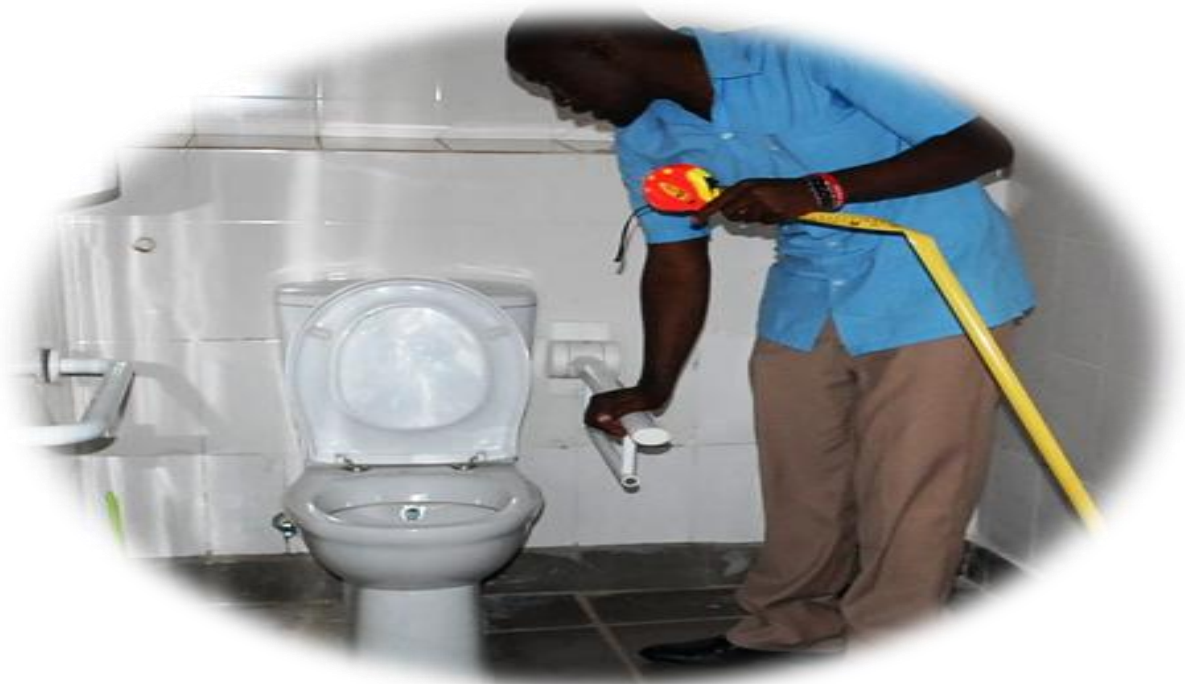
- iv. The toilet stance reserved for PWDs is always closed, the floor tiles are too smooth posing danger to users, the toilet paper holder is placed at a high position for a crawling /seated disabled person.

PWD toilet in KCCA building

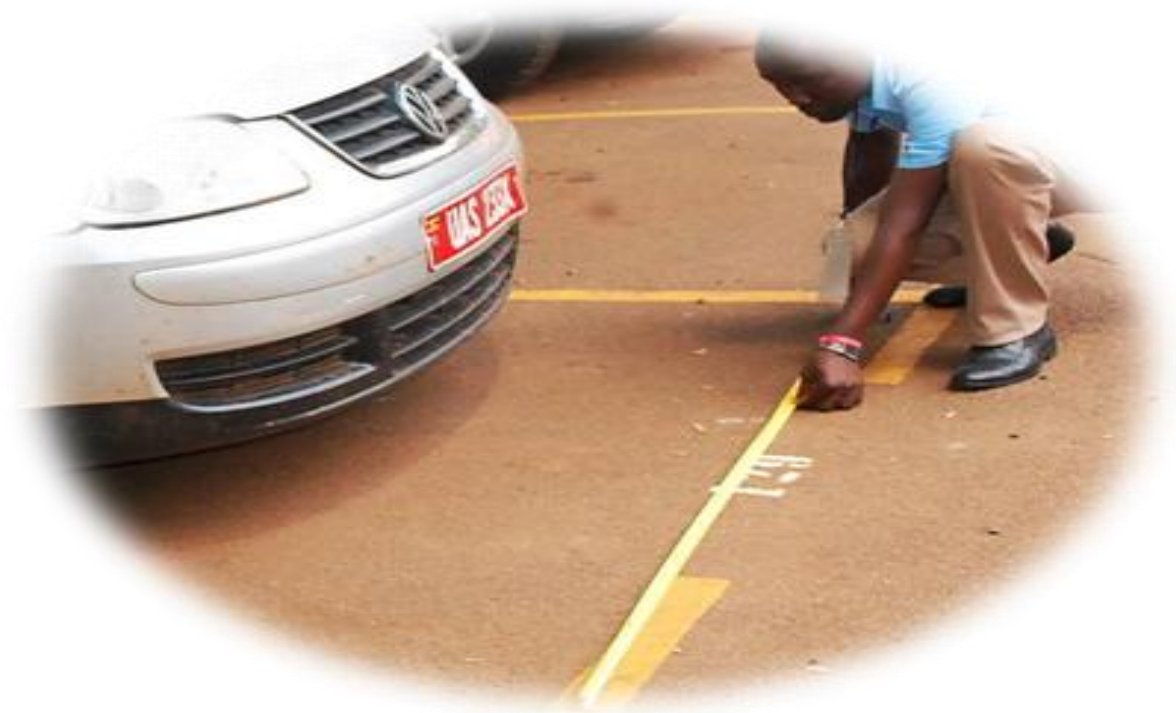
- v. The premises do not have a designated parking for PWDs and the parking yard is not in a logical relationship with the pathways.

Existing Parking Space at KCCA without provision for PWDs

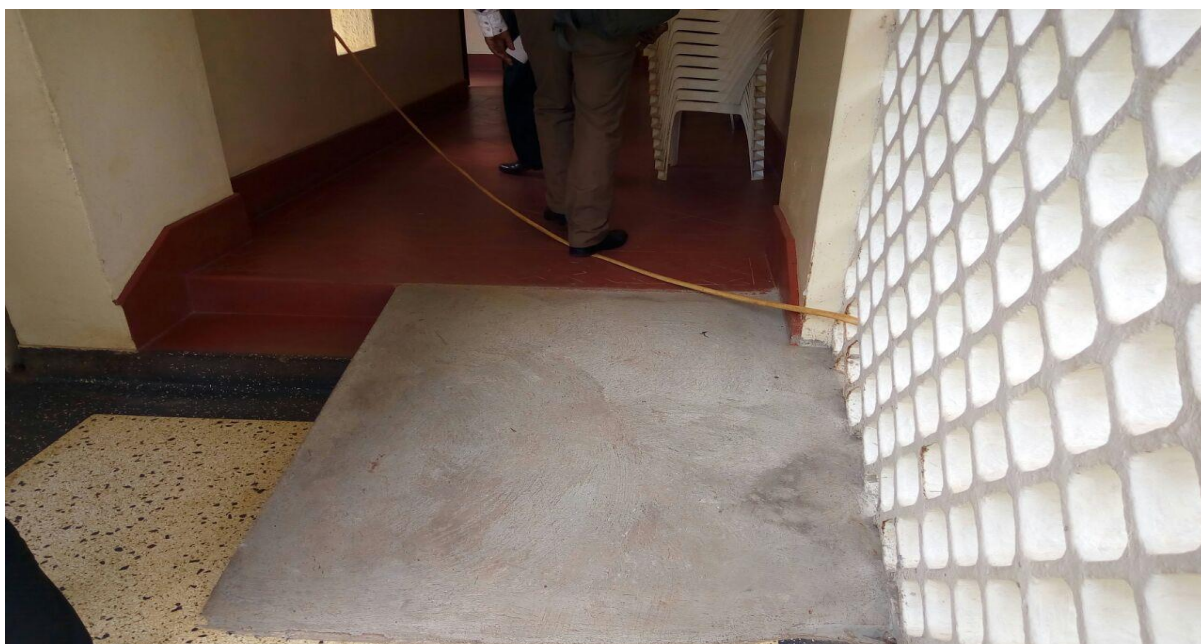
- vi. In spite of being an old building, lifts were installed during renovations to ease movement from one floor to another especially for the wheel chair users. The lifts are also brailed which makes them user friendly for those who are visually impaired.
- vii. KCCA premises specifically the Mayors parlor have ramps within the corridors of the building which ease movement for PWDs especially those using wheel chairs. On the contrary the ramps do not have handrails that provide support in movement for PWDs.

Modified steps with Ramps within the corridors

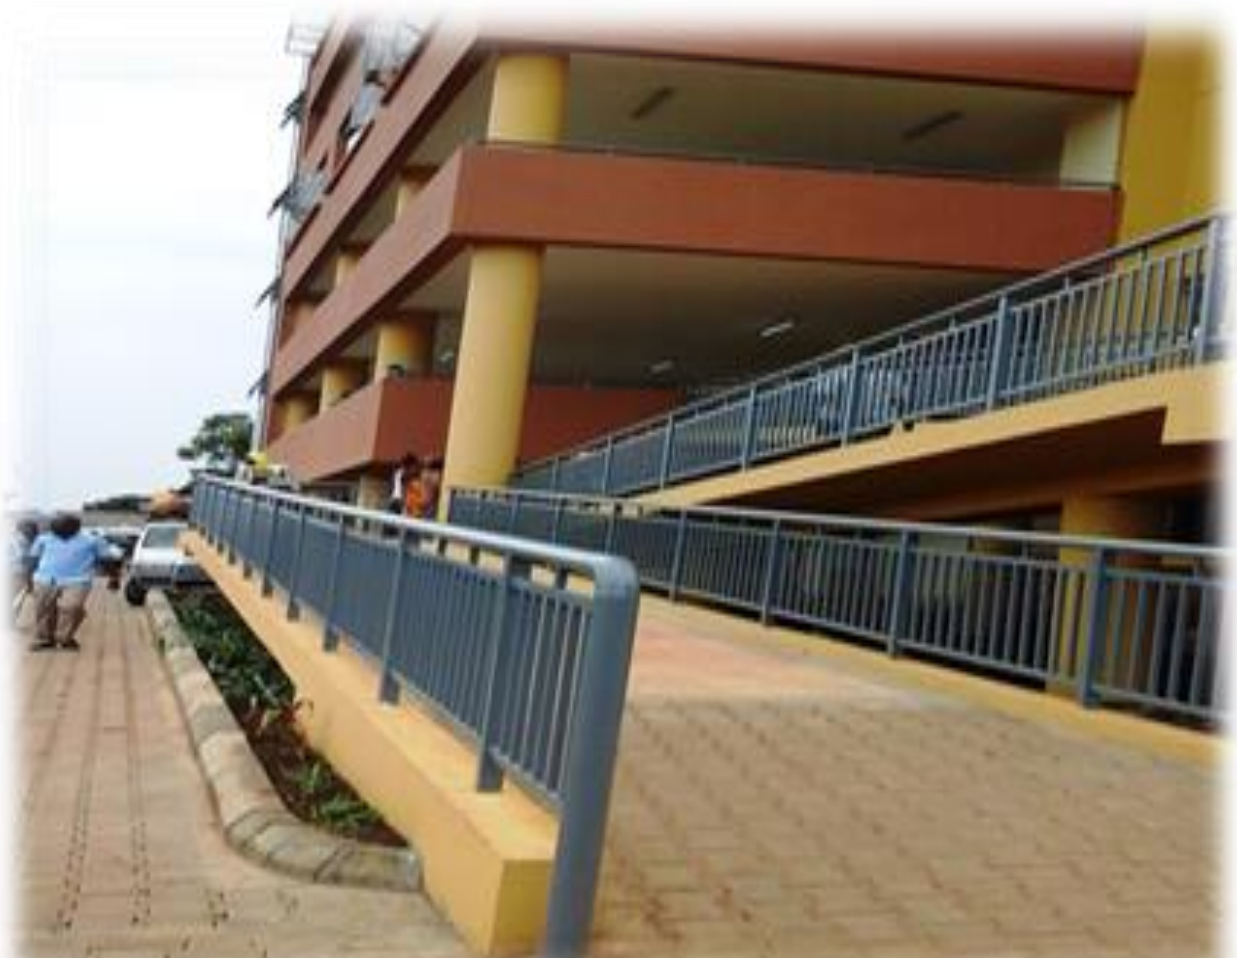
- i. The main entrance to the hospital has a ramp with a gentle slope, however the rails on the ramp are of a very big diameter which cannot be easily grabbed and the ramp does not have tactile marking at the start and end points.

Main Entrance at Kiruddu Hospital

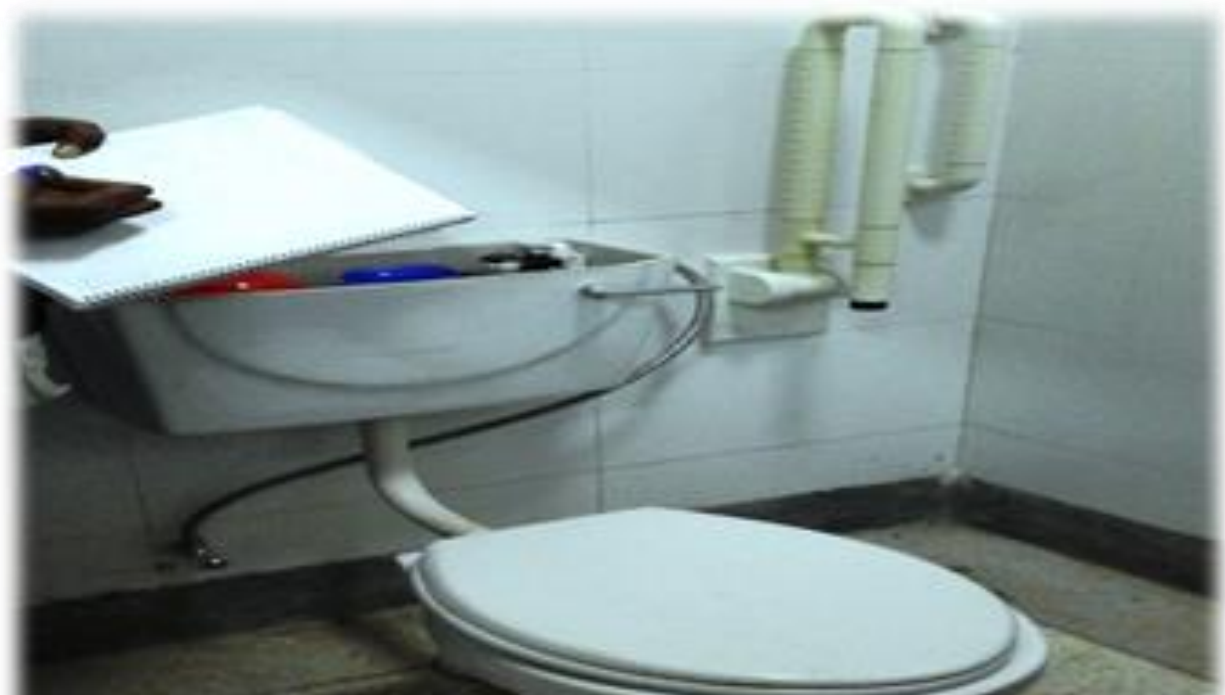
- ii. The premises do not have a designated parking space for Persons with Disabilities.
- iii. The handrails in the PWD toilets are fixed very high relative to the sitting position; there is no toilet paper holder; and the door does not rest flat against the wall for ease of entry by wheel chair users.

PWD Toilet room in Kiruddu General Hospital

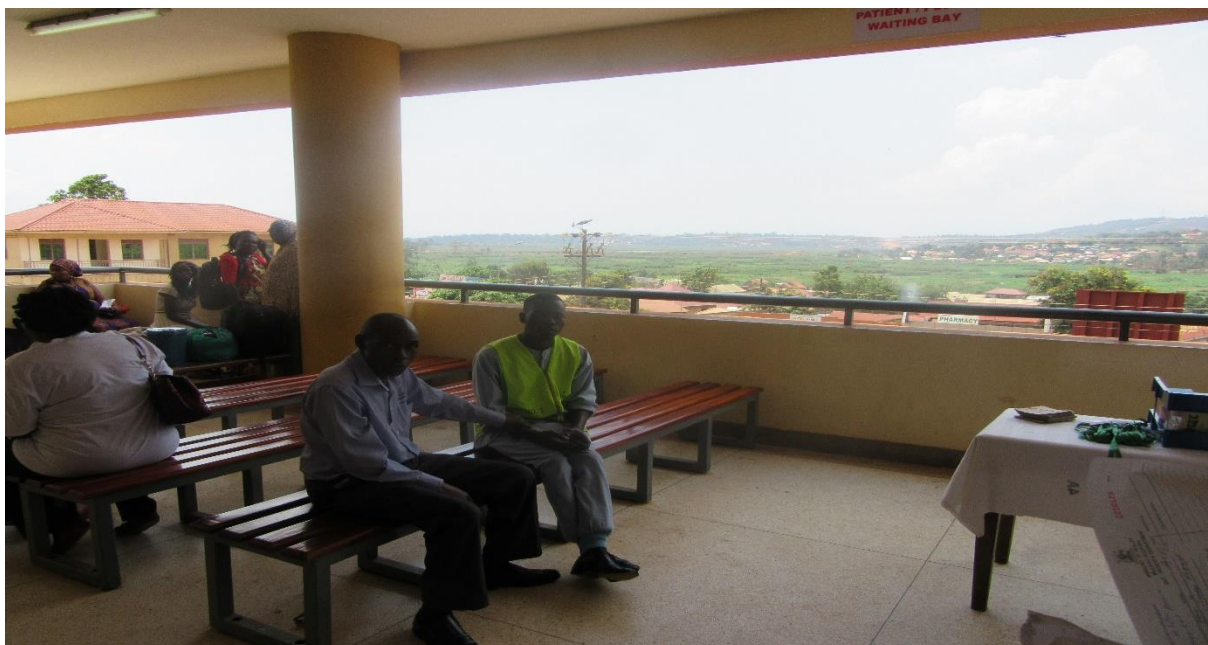
- iv. The public seats are of hard wood, not covered with soft material and lack a back rest which makes them unfavourable for Persons with Disabilities and persons with weak muscles.

Public seats at Kirruddu General Hospital without a back rest

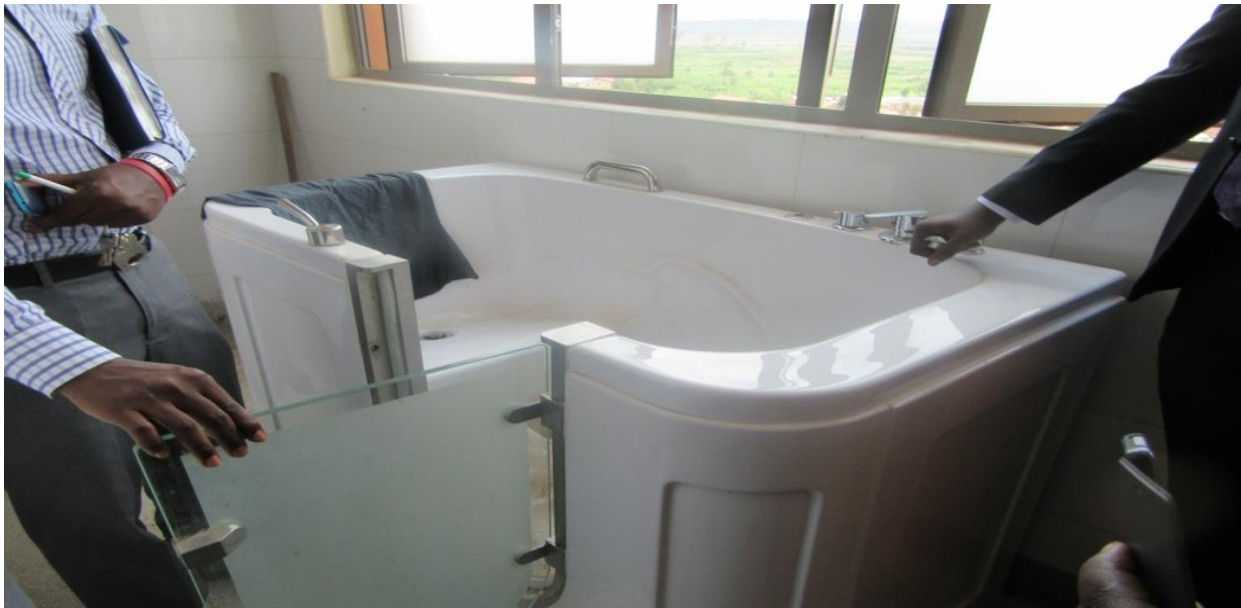
- v. The hospital has a special assistive bathtub specifically designed for Persons with Disabilities.

Assistive Bathtub at the hospital for PWDs

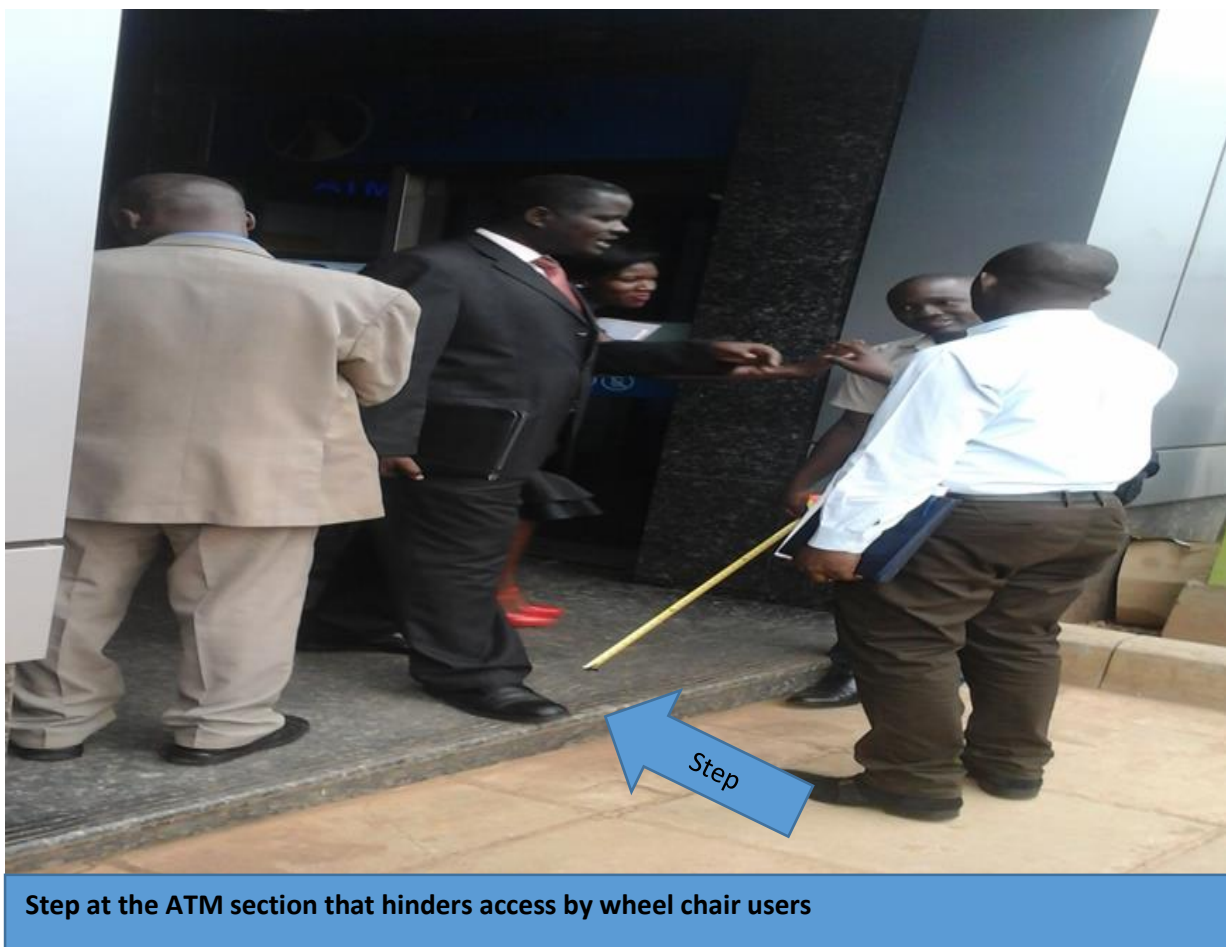
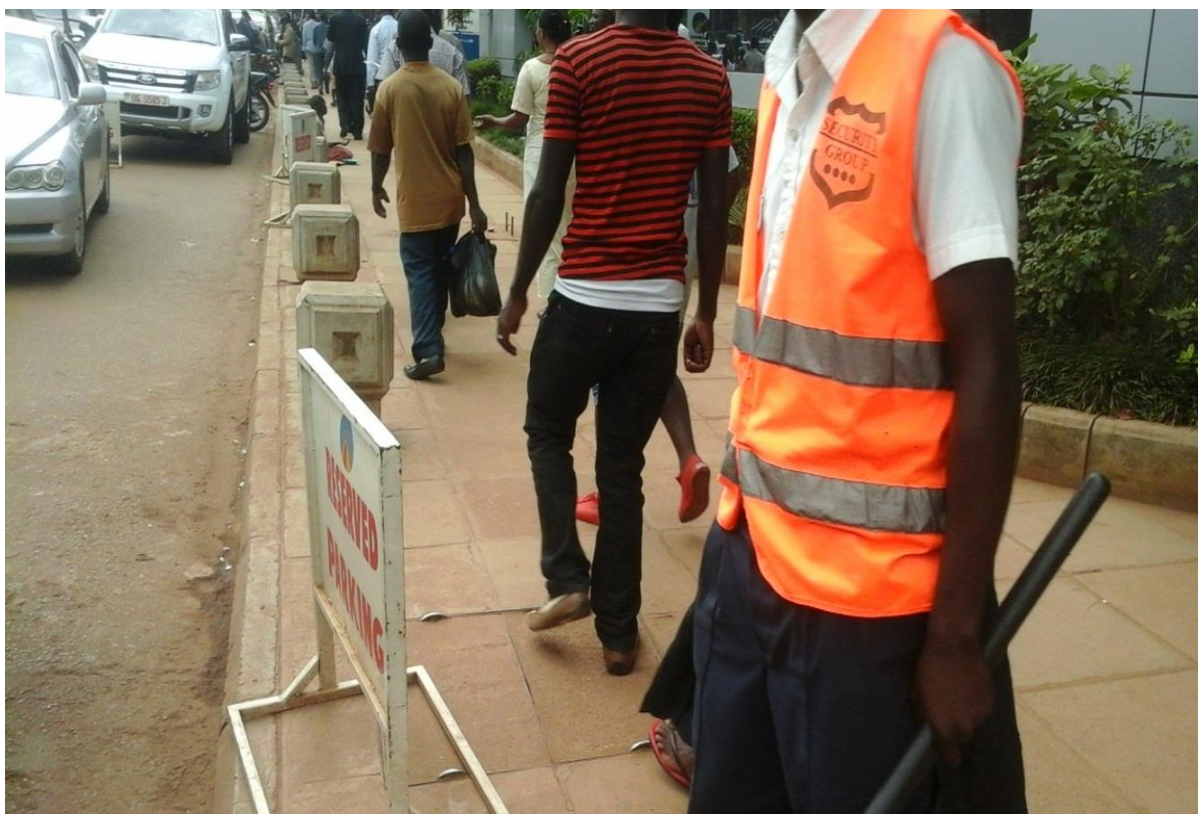
- i. There is a step on the main road that limits wheelchair users from accessing the walkway to the ATM section.
- ii. There is a raised pavement towards the entrance at the main road that hinders access to the walk way for wheel chair users.

Raised pavement at the main road entrance that hinders access to the walkway for wheel chair users

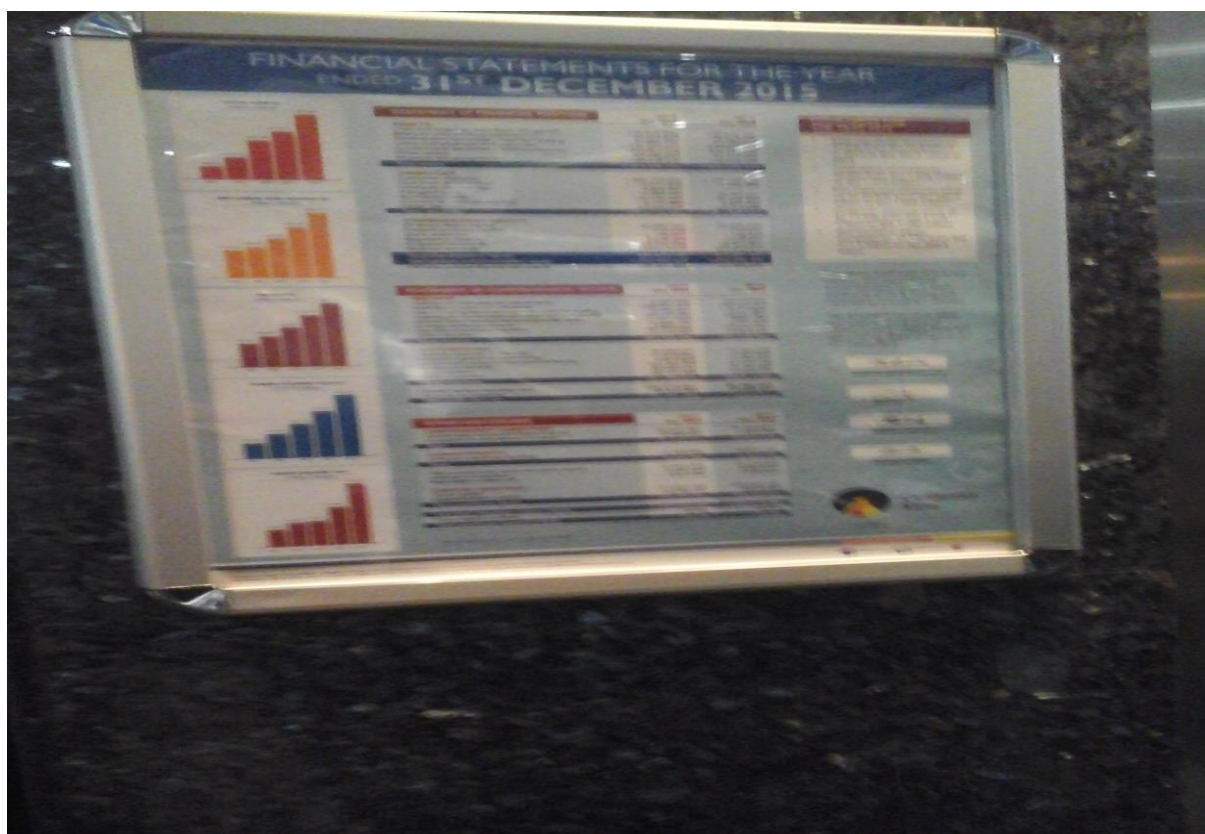
- iii. The door to the washrooms for PWDs is not labelled with a disability symbol, the floor is very slippery and the pull and push handle of the door are placed very high particularly for the wheel chair users and little persons.
- iv. The bank has a very small notice board that is placed high on the wall with information in small print that cannot be easily read by clients and staff who are visually impaired.

Noticeboard with small print in the banking hall

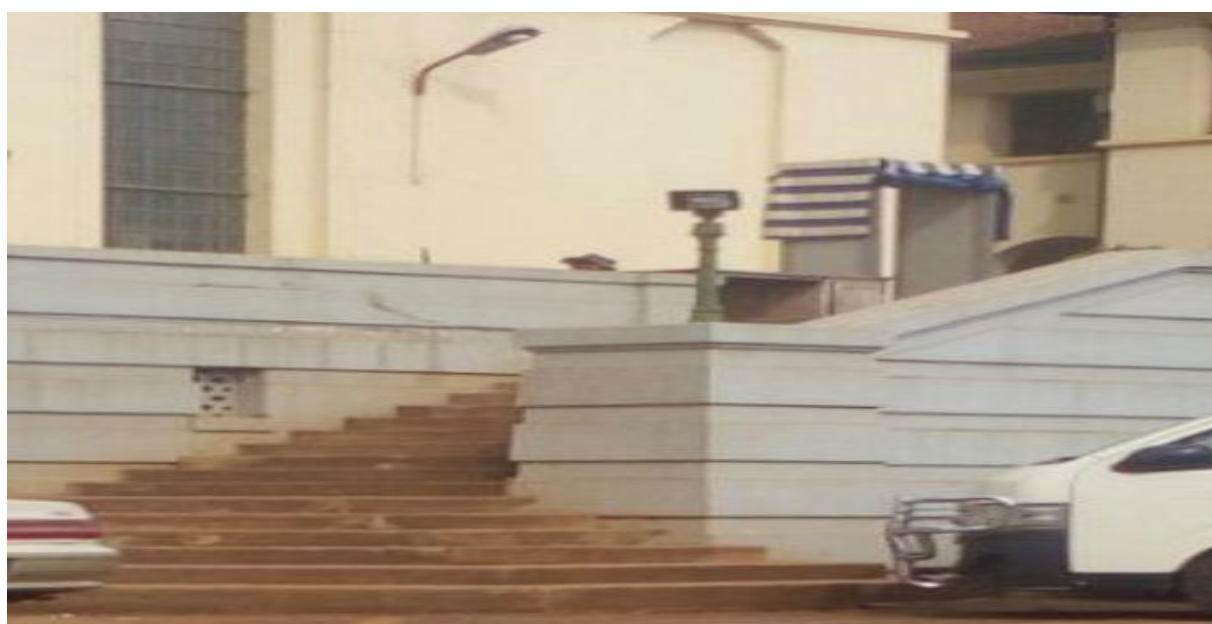
- i. The main entrance to the High Court Building, Kampala is not accessible for PWDs as it does not provide for a ramp.
- ii. The stairs at the main entrance do not have handrails and tactile markings hence making them inaccessible by Persons with Disabilities.

Main entrance to the Kampala High Court building does not have provision for a ramp to ease access by Persons with disabilities

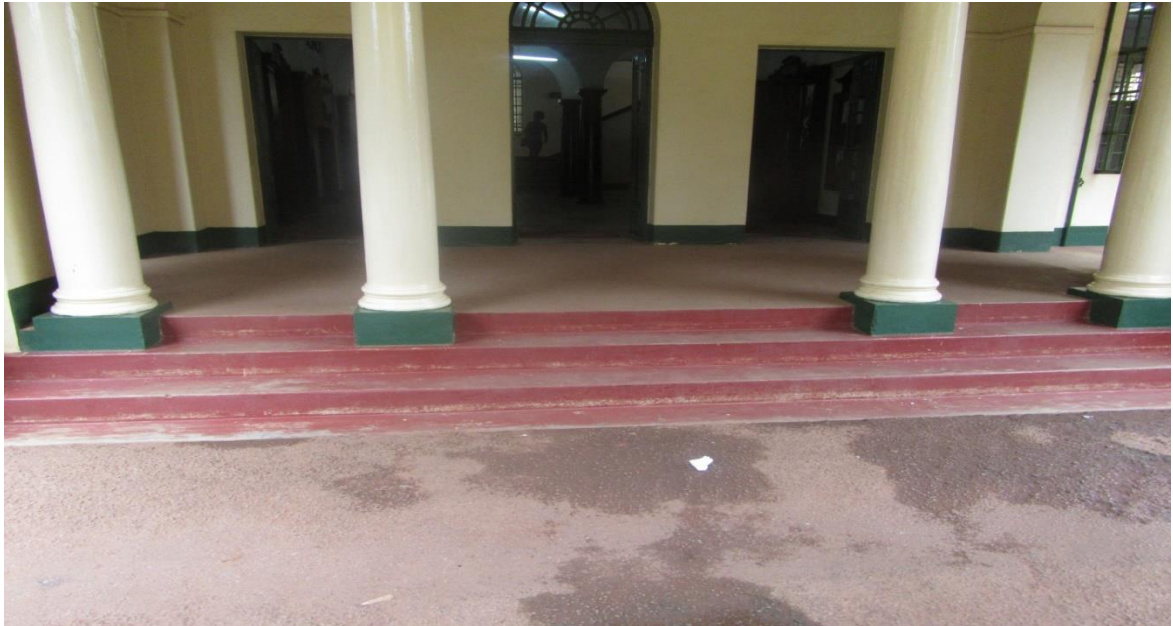
The court has an alternative entrance that could possibly be used by PWDs however it equally has stairs without a ramp which makes it inaccessible by PWDs. The audit team was informed that when they receive PWD clients a temporary ramp is usually placed on the stairs to ease access to the court by this group of clients.

In accessible alternative entrance at High Court used by PWDs

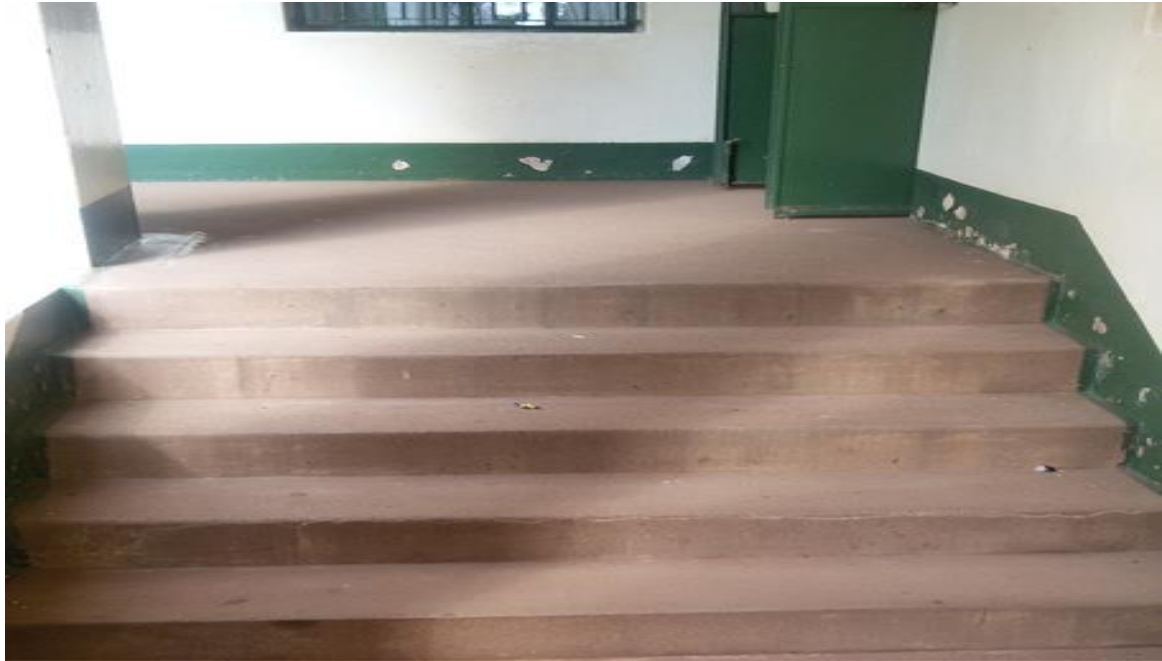
- iii. The High court building does not have any designated and clearly marked parking space for Persons with Disabilities.
- iv. In the entire High court building, there are no designated washrooms for Persons with Disabilities.
- v. The corridors in the high court building have interior stairs without provision for a ramp which impede easy movement for PWDs within the building. Similarly the stairs lack handrails and tactile markings which help the visually impaired to detect a change in direction.

Interior stairs at Kampala High Court premises without a ramp, handrails and tactile markings

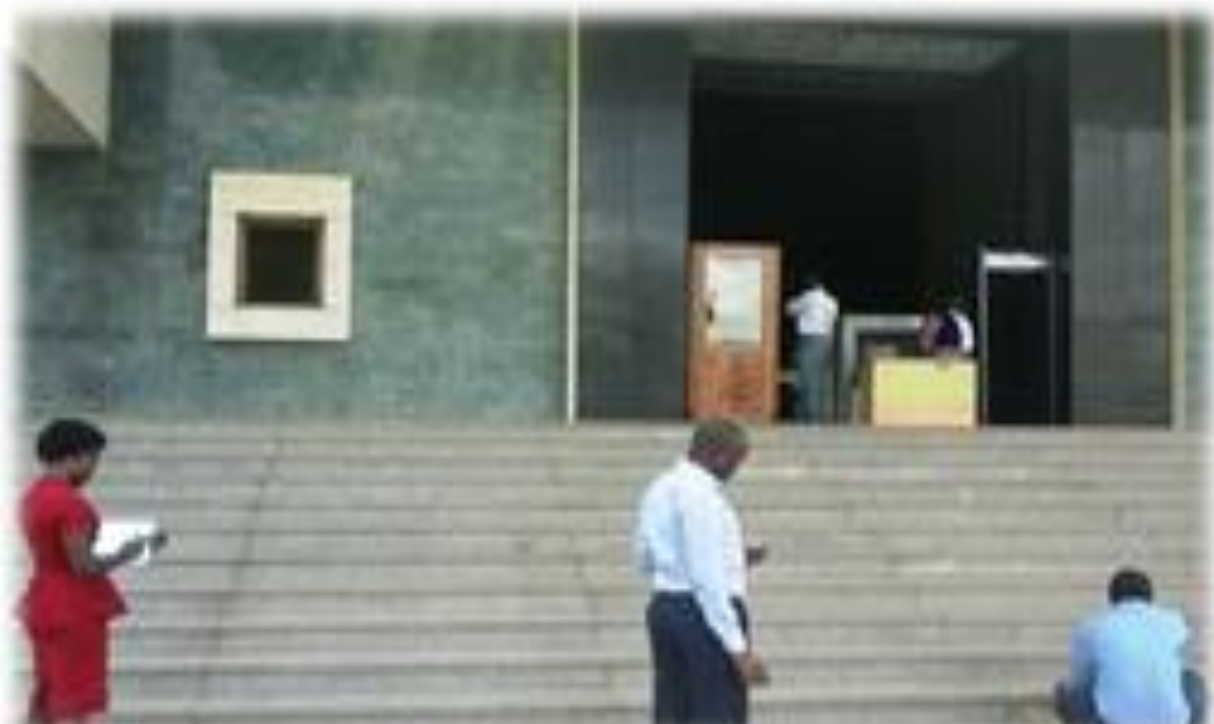
- i. The entrance to the south wing has a ramp for ease of access by PWDs however the ramp does not have tactile marking for easy identification and the landing area is very slippery.
- ii. The exterior stairs at parliament do not have handrails (both general and intermediate) to support movement.

Exterior steps at the entrance without hand rails
